## **Public Health Assessment**

### **Evaluation of soil, groundwater, and vapor intrusion contamination at open and closed investigations on the Hartmeyer and Oscar Mayer sites in Madison, WI**

Hartmeyer & Oscar Mayer Sites  
2007 Roth St & 910 Mayer Ave  
Madison, Wisconsin

January 20, 2023

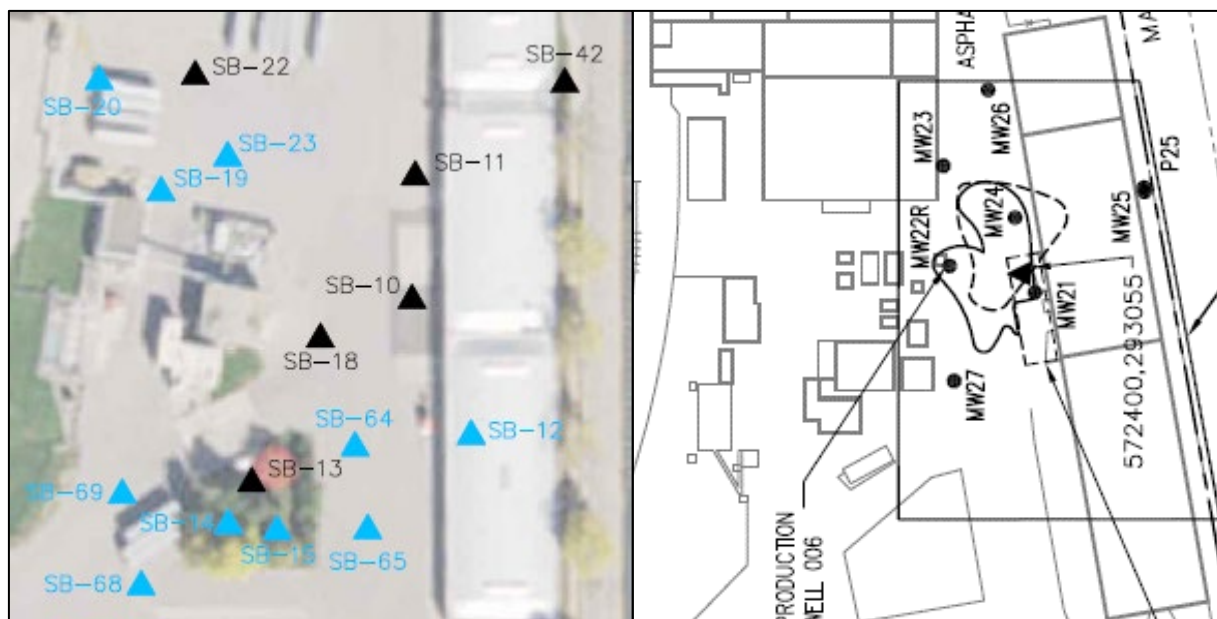
**Figure 4. Closed Site #3 with 2017 data near site (left) and 1996 (right) extent of contamination.**

Closed Site #3 (BRRTS 03-13-114831) is located just west of The Bodgery building on the South side of the Central portion of the Oscar Mayer Property (Figure 4). An underground storage tank (UST), former diesel dispensers, and several former gasoline dispensers were excavated for removal from the site. Following excavation, the site was backfilled with clean fill and a new diesel UST. The former UST excavation for gasoline was also backfilled. Following the original excavation,

soil and groundwater analytical results were taken in 1996 and 1997 from the excavation to determine soil and groundwater contamination at the site. The cap is required to be maintained and inspected annually to determine its integrity. Sampling was also performed on this site as part of the 2017 Oscar Mayer investigation. Additional soil samples and groundwater samples were taken throughout Oscar Mayer property in 2017. The samples were also taken on the former 1,2-DCA tank site and from the area near Closed Site #3 (Figure 4 and Figure 5). Soil samples in the top 5 feet of soil (SB-11, SB-12, SB-18, SB-19, SB-23, SB-42) where the soil is most accessible, and groundwater samples (SB-10, SB-12, SB-18, SB-19, SB-23, SB-42, SB-64) were also taken near the former UST site behind the Bodgery.

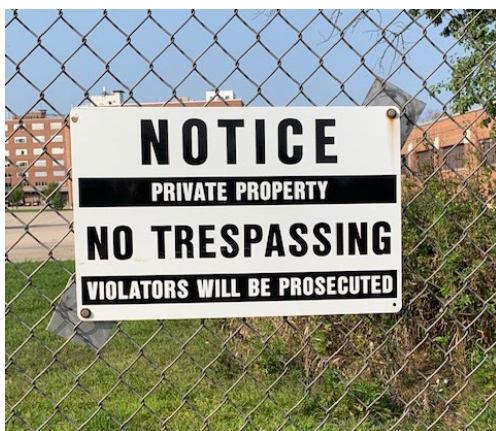
**Figure 7. Trepassing sign on the central Oscar Mayer Property near back of Bodgery building.**

Bodgery, there is a “garage door” type entrance to the building and a side door. Both appeared to not be in use (Figure 6). The fencing right outside this area does have a “No Trespassing” sign (Figure 7). A building at the back of the lot did appear to be in use with cars parked in the parking lot but it appeared to be for the building labeled “Nine-Ten” which is being leased out by a third party company. Upon further

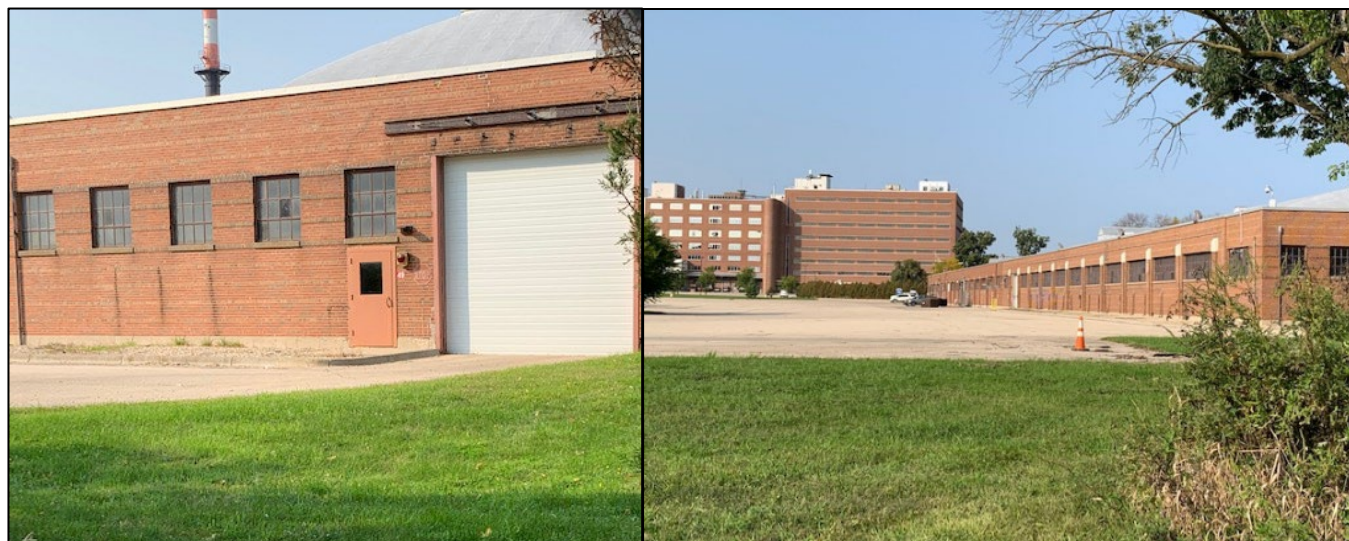
**Figure 8. The south side of the Bodgery building adjacent to the former 1,2-DCA tank site**

- 1) Deed restrictions that require a surface barrier over the remaining soil contamination in order to prevent contamination from impacting human health through direct contact and to prevent contamination from impacting groundwater due to the infiltration of precipitation. The deed restriction also requires the property owner to investigate the degree and extent of residual contamination that is currently inaccessible if and when structural impediments that currently exist on the property are removed.
- 2) If contamination remains, all current and future owners and occupants of the property need to be aware that excavation of the contaminated soil may pose an inhalation or other direct contact

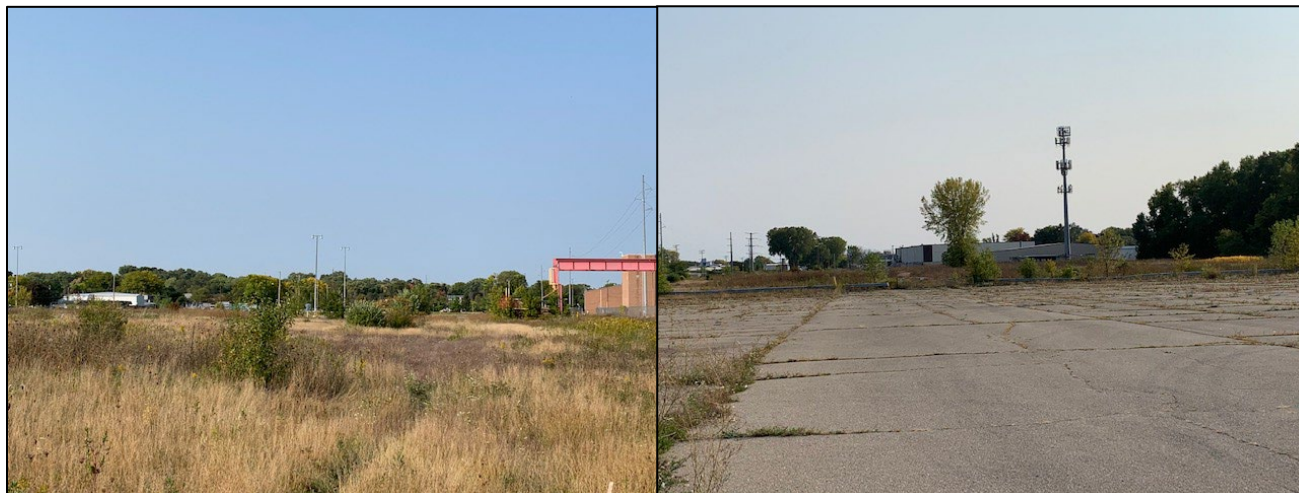
**Figure 10. Hartmeyer site looking South to North (left photo) and looking north to South (right photo).**

Closed site #2, located within the Hartmeyer property, had residual fuel oil petroleum contamination originating from the distribution lines associated with the aboveground storage tank area located on the Hartmeyer property. These tanks have been removed and no indication of them can be seen on the Hartmeyer Site (Figures 10 and 11). The Wisconsin & Southern Railroad at the time was considered an adjoining property that was impacted by the contamination and they were notified. In 2006, the extent of the plume on the site was well defined and limited to the general area as defined by Figure 14. Because Closed Site #2 is part of the Hartmeyer property, we considered information from the 2019 investigation as well as the data from Closed Site #2 investigation when evaluating exposure pathways and health risks. For soil concentrations, we used the 2019 values as they were more up to date and distinguished individual compounds (e.g., benzo[a]pyrene). Some past samples were analyzed for “diesel range organic compounds” which is no longer tested for in site investigations since it measures the concentration of a mixture of compounds.
